DEVELOPMENT OF WELDING TECHNIQUES AND FILLER
METALS FOR HIGH STRENGTH ALUMINUM ALLOYS

Annual Summary Report
Project No. 07-1063

SOUTHWEST RESEARCH INSTITUTE
SAN ANTONIO HOUSTON

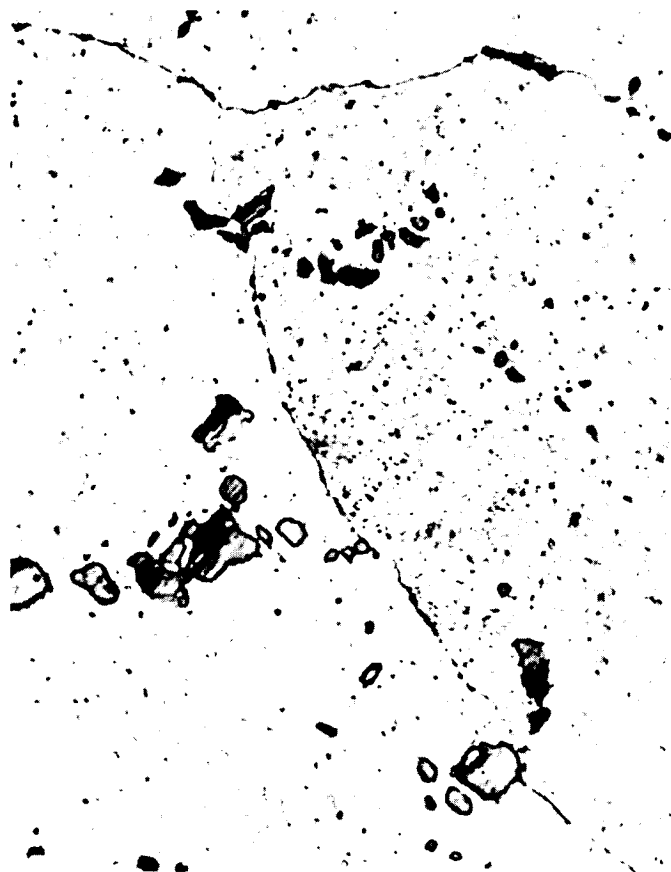
FIGURE 1. MICROSTRUCTURE OF 2219-T87
PARENT METAL

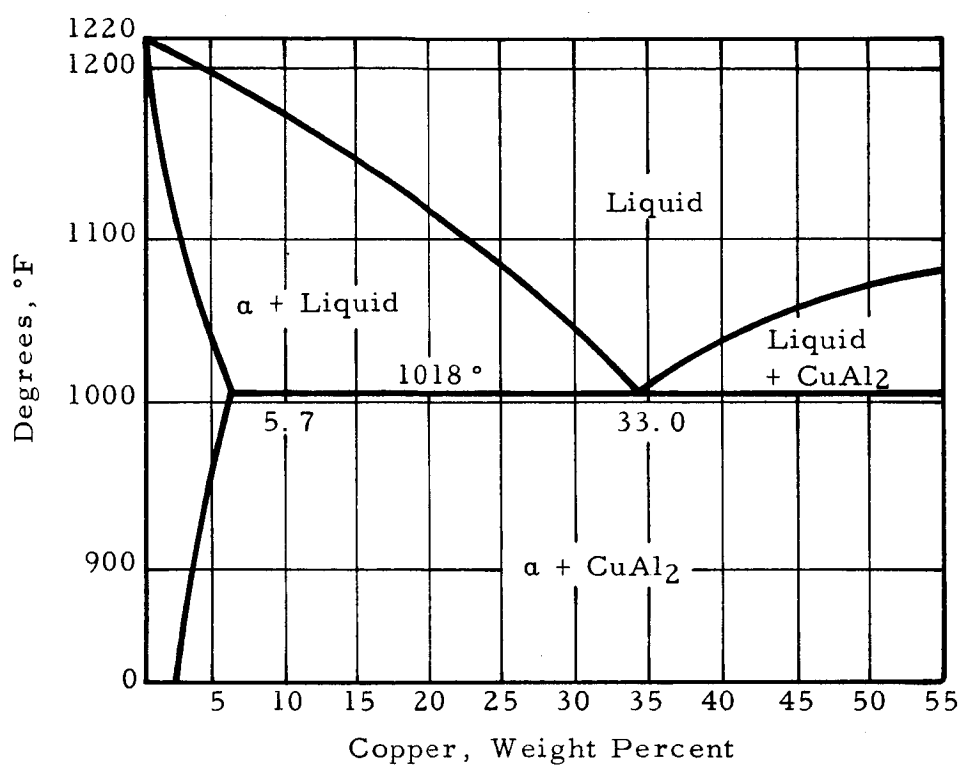
FIGURE 2 . ALUMINUM RICH END OF Al-Cu BINARY PHASE DIAGRAM.

From the Al-Cu equilibrium diagram shown in Figure 2, it can be seen that upon cooling a molten alloy of less than 33 percent Cu, α solid solution is the first phase to form. At 1018°F , the eutectic of α and CuAl_2 precipitates in the grain boundaries. Under welding conditions the cooling rate is rapid and equilibrium is not established. In addition, all welding was performed in the horizontal position. Welding in this position is thought to be significant to the formation of the Chinese script and the "needle" phase. In the horizontal position, the liquid metal tends to sag at the bottom toes as shown in Figure 8. It is thought that the unique cooling rate experienced by the sagging toe of the weld may be responsible for the formation of CuAl_2 with a Chinese script appearance. Additional information concerning cooling rate as a factor in the formation of the CuAl_2 network is presented in Appendix I.

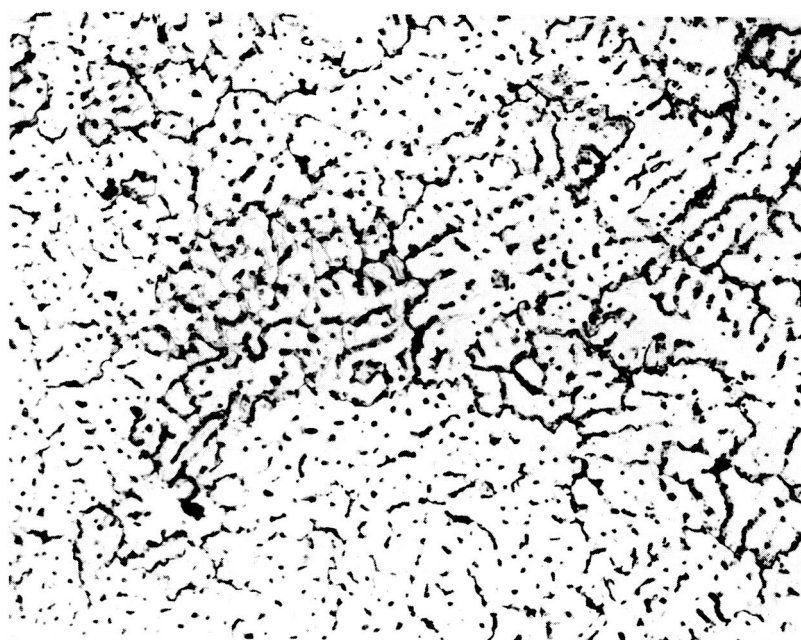
FIGURE 4. WELD METAL STRUCTURE IN FIRST AND SECOND
WELD PASSES OF A 2219-T87 WELDMENT

The microstructures of the first and second weld passes are shown in Figure 4. Both photomicrographs show the CuAl_2 phase in the grain boundaries of the alpha (α) solid solution matrix. During welding this material is melted and solidifies rapidly. The precipitated CuAl_2 in the matrix is taken into solution and the Cu is held in a supersaturated solution in the α phase. The CuAl_2 from the eutectic reaction coalesces as large particles of discontinuous Θ phase in the grain boundaries.

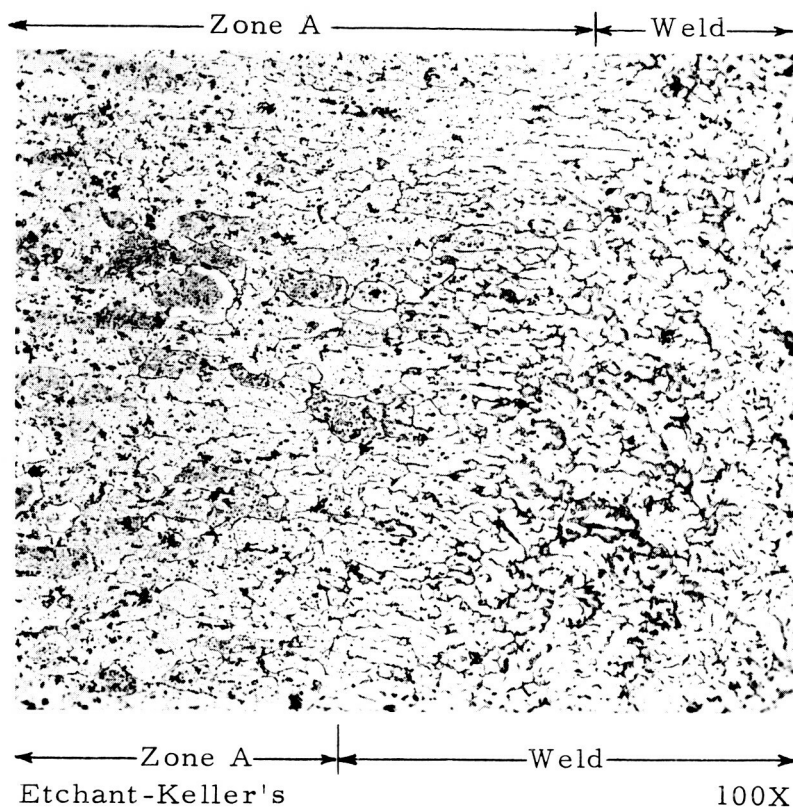
FIGURE 5. WELD METAL AND ZONE A OF A 2219-T87 WELDMENT

Figure 5 is a photomicrograph of the fusion found at the interface of deposit and Zone A. This structure is shown at higher magnification in Figure 6. It is evident in this photomicrograph that CuAl_2 has coalesced in the grain boundaries and another unidentified phase has precipitated in the matrix. The structural changes in Zone A are shown in Figure 7. The metal has been heated sufficiently to cause diffusion and coalescence of a portion of the Cu to the grain boundaries. This Cu forms additional CuAl_2 and adds to the CuAl_2 already present in the grain boundaries to form a continuous phase.

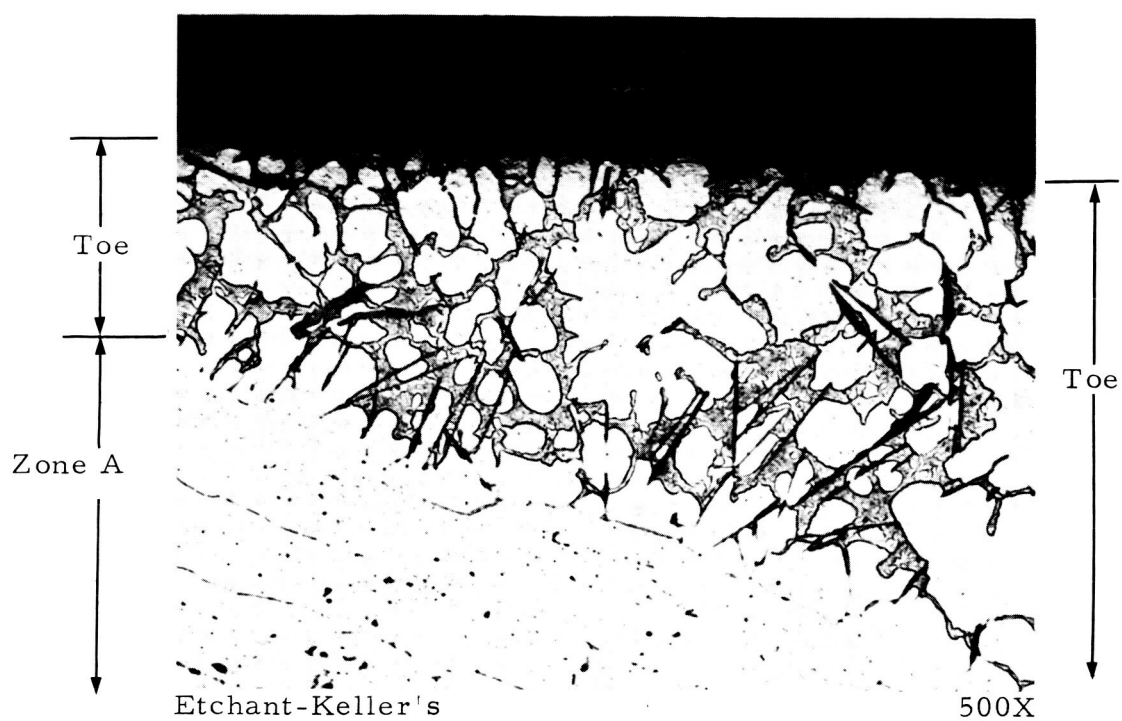
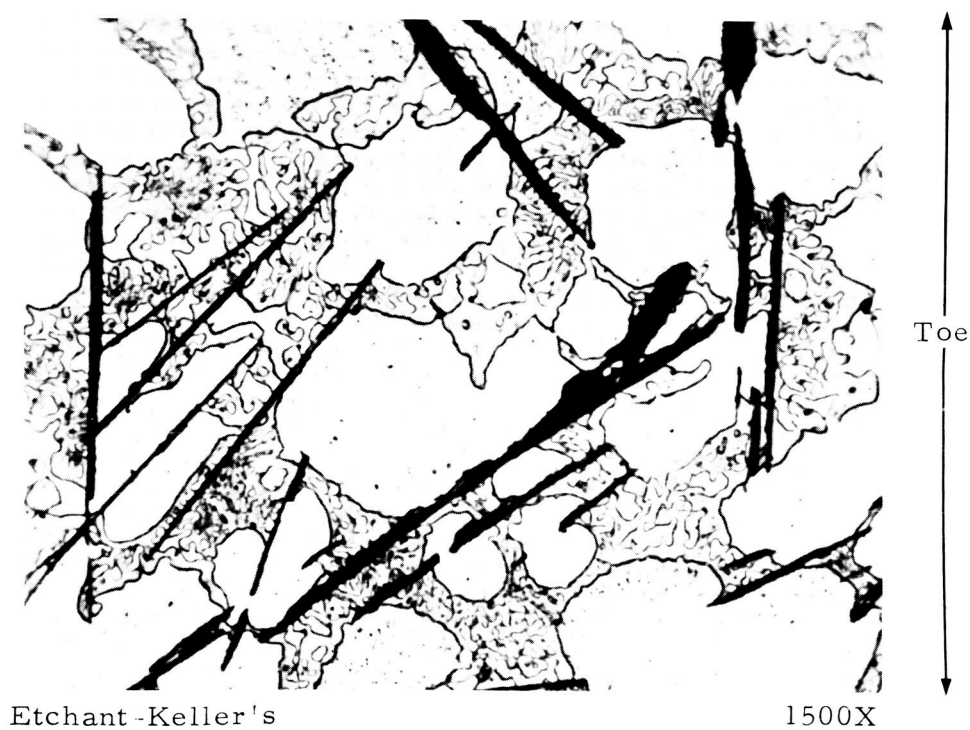
FIGURE 9. CONCENTRATION OF INTERMETALLIC CONSTITUENTS
IN THE BOTTOM TOE OF A WELD

at higher magnification. Two outstanding features may be observed in these photomicrographs. The CuAl_2 occurs as an intergranular Chinese script network. Also, there is a "needle" like phase. Both of these phases could form as a result of a unique combination of chemical composition, temperature, and cooling rate which is present at the bottom toe of the weld.

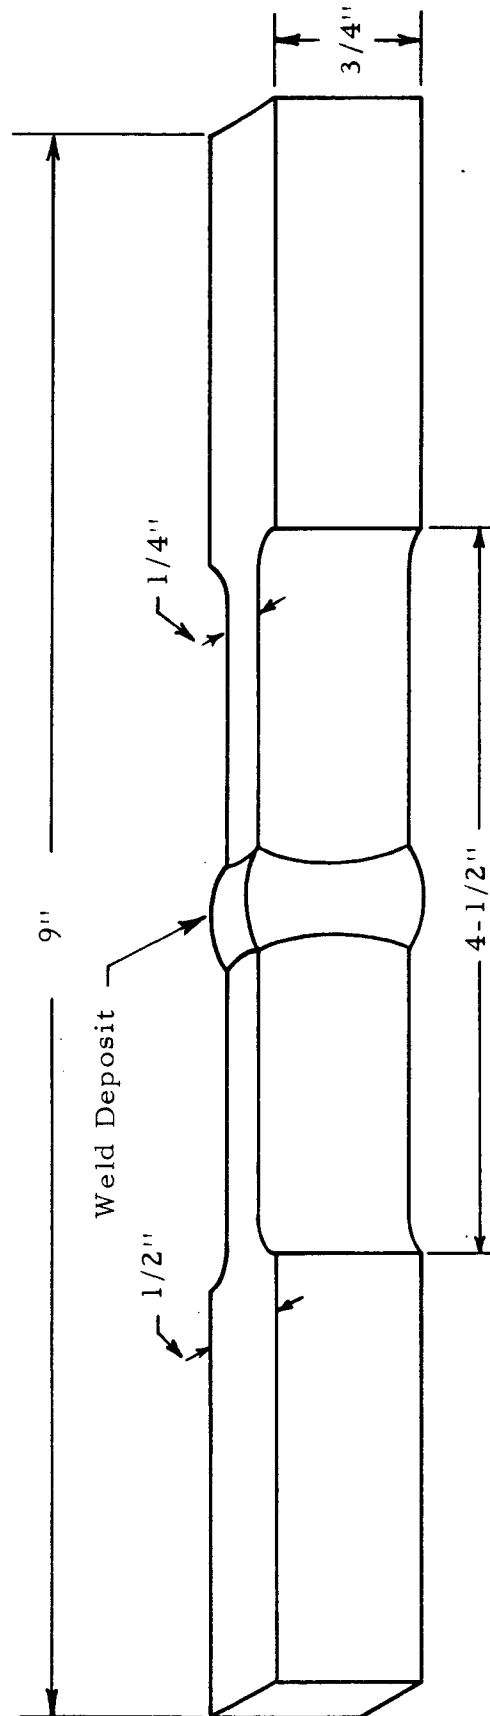
FIGURE 10. TENSILE SPECIMEN

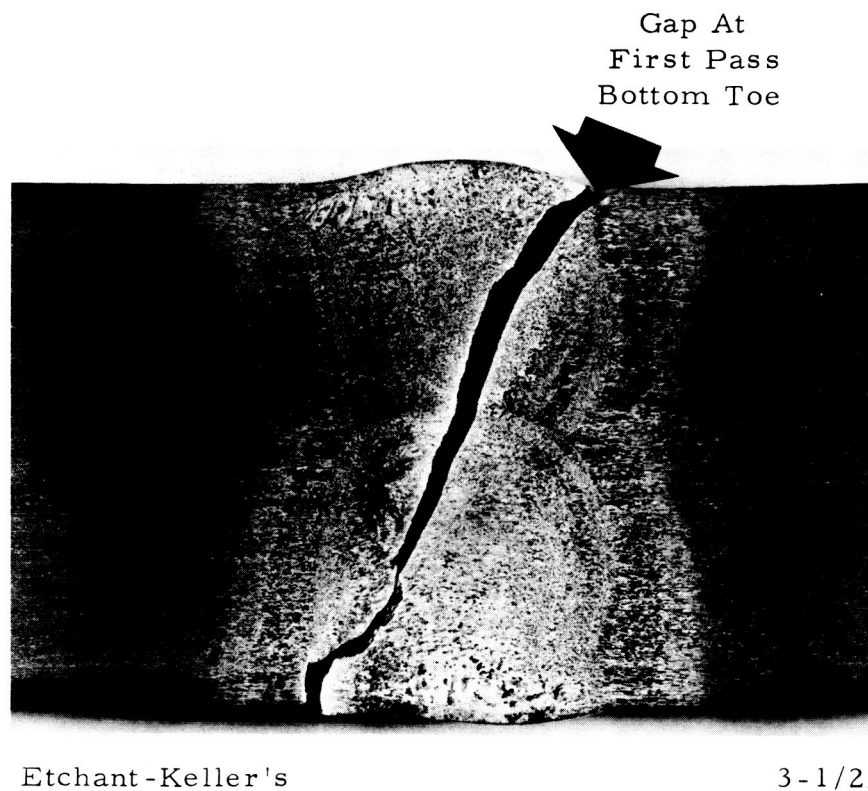
FIGURE 11. APPEARANCE OF A TYPICAL GAP IN THE FRACTURE
PATH OF A BROKEN TENSILE SPECIMEN AFTER
BUTTING THE FAILED PIECES TOGETHER

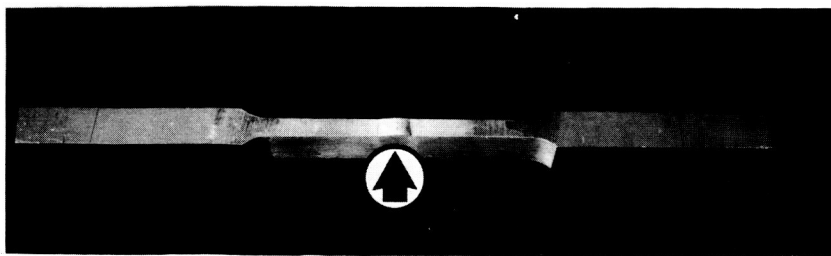
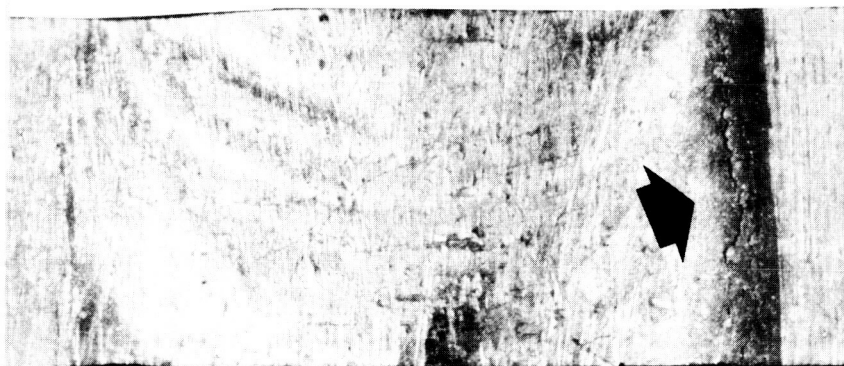
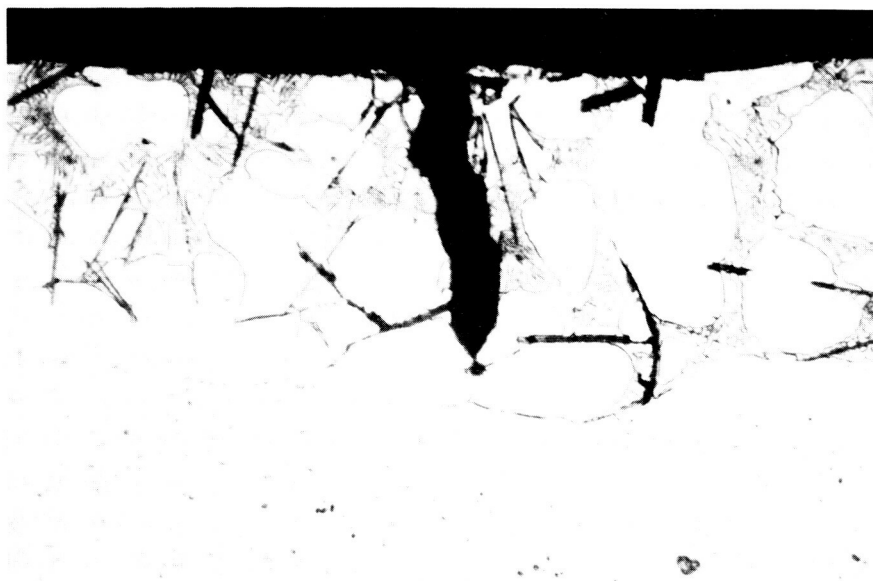
1/4X
Stressed Tensile Specimen Showing Weld Crown

8X
Cracks In Bottom Toe Of The Weld Crown After Stressing

Etchant-Keller's
Microstructure Of One Of The Cracks
1000X

FIGURE 12. FRACTURE INITIATION IN BOTTOM TOE OF
HIGHLY STRESSED TENSILE SPECIMEN

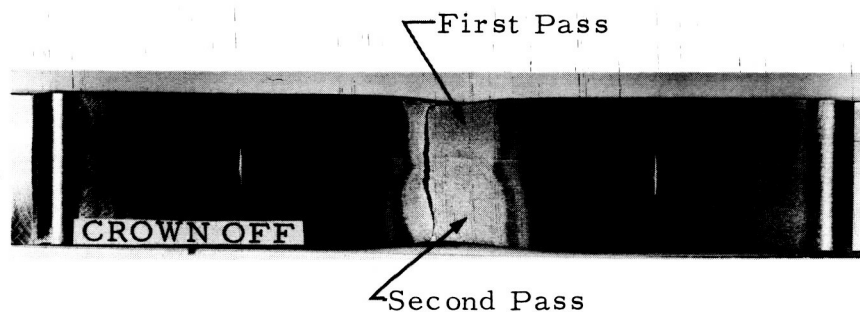
FIGURE 13. FRACTURE PATH IN A TENSILE SPECIMEN WITH WELD CROWNS MACHINED OFF

Figure 13 shows the fracture path of a specimen with the weld crowns removed. The propagation was straight through the weld deposit. Observation of the fracture geometry indicated that the failure initiated in the center of the weld thickness. Tests conducted on individual tensile specimens machined out of the first weld pass and second weld pass also displayed a failure path through the weld metal. Figure 14 shows that the fracture occurred diagonally through the weld deposit in both specimens.

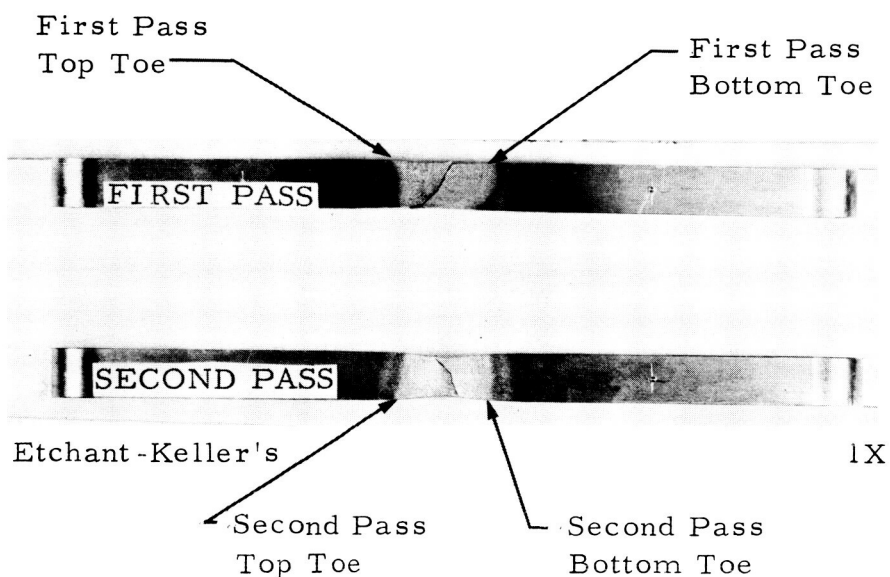
FIGURE 14. THE FRACTURE PATH IN ADJOINING FIRST AND SECOND WELD PASSES WHEN TESTED AS SEPARATE TENSILE SPECIMENS

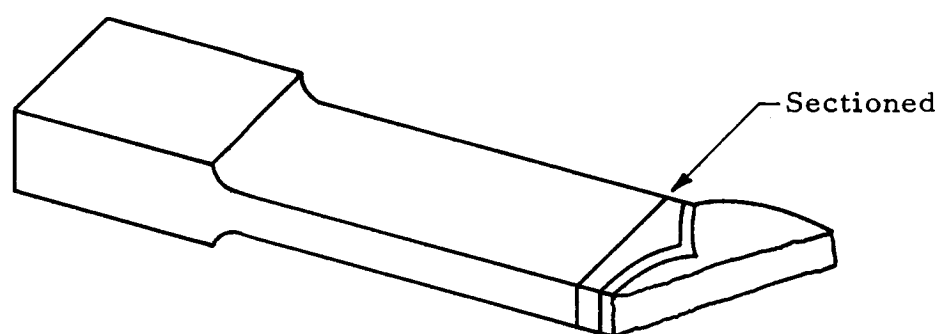
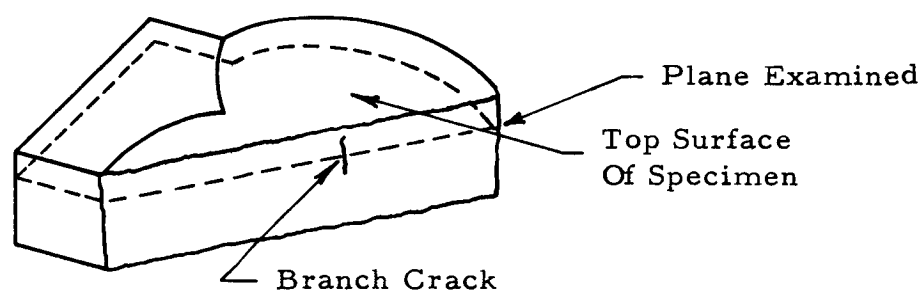
Half Of Tensile Specimen After Testing

Section Of Failure Examined

FIGURE 16. SCHEMATIC OF SECTION OF SPECIMEN USED TO STUDY FRACTURE PATH IN 2219-T87 WELDMENTS

The procedure is illustrated schematically in Figure 16. The failed tensile specimen containing the branch cracks was sectioned and polished on planes parallel to the top surface.

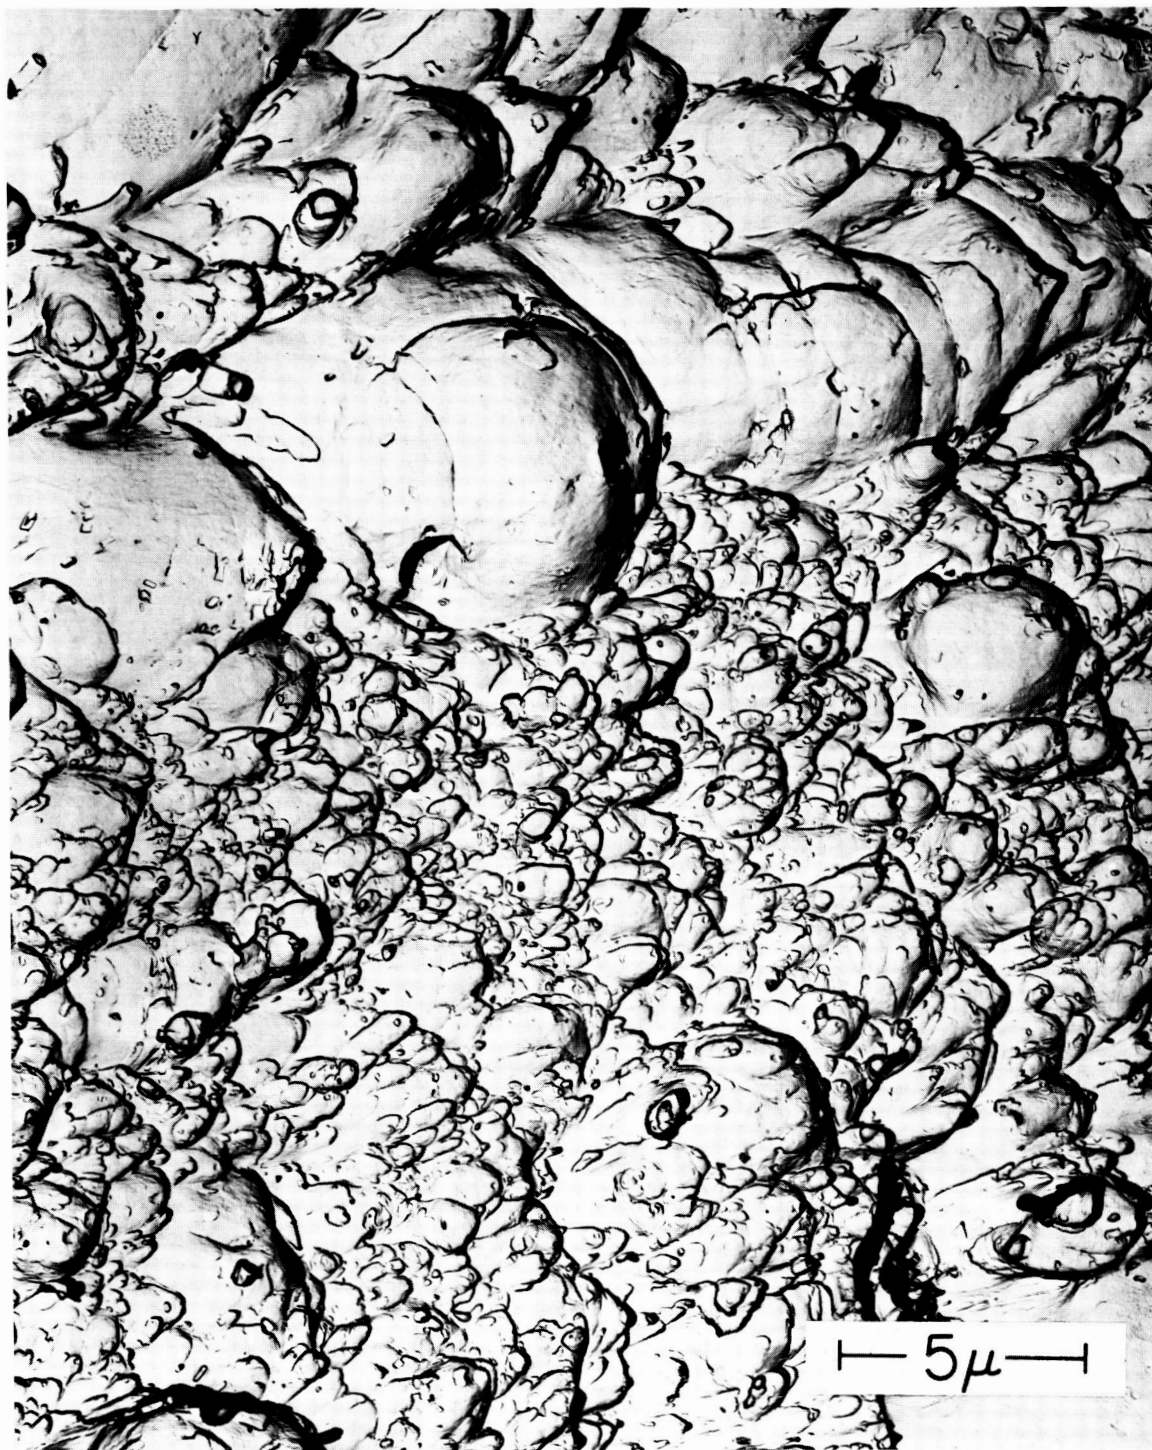
FIGURE 20. FRACTURE SURFACE OF 2219-T87 BASE METAL TENSILE SPECIMEN. Fractograph taken in shear lip region. Note the range of size of dimples.

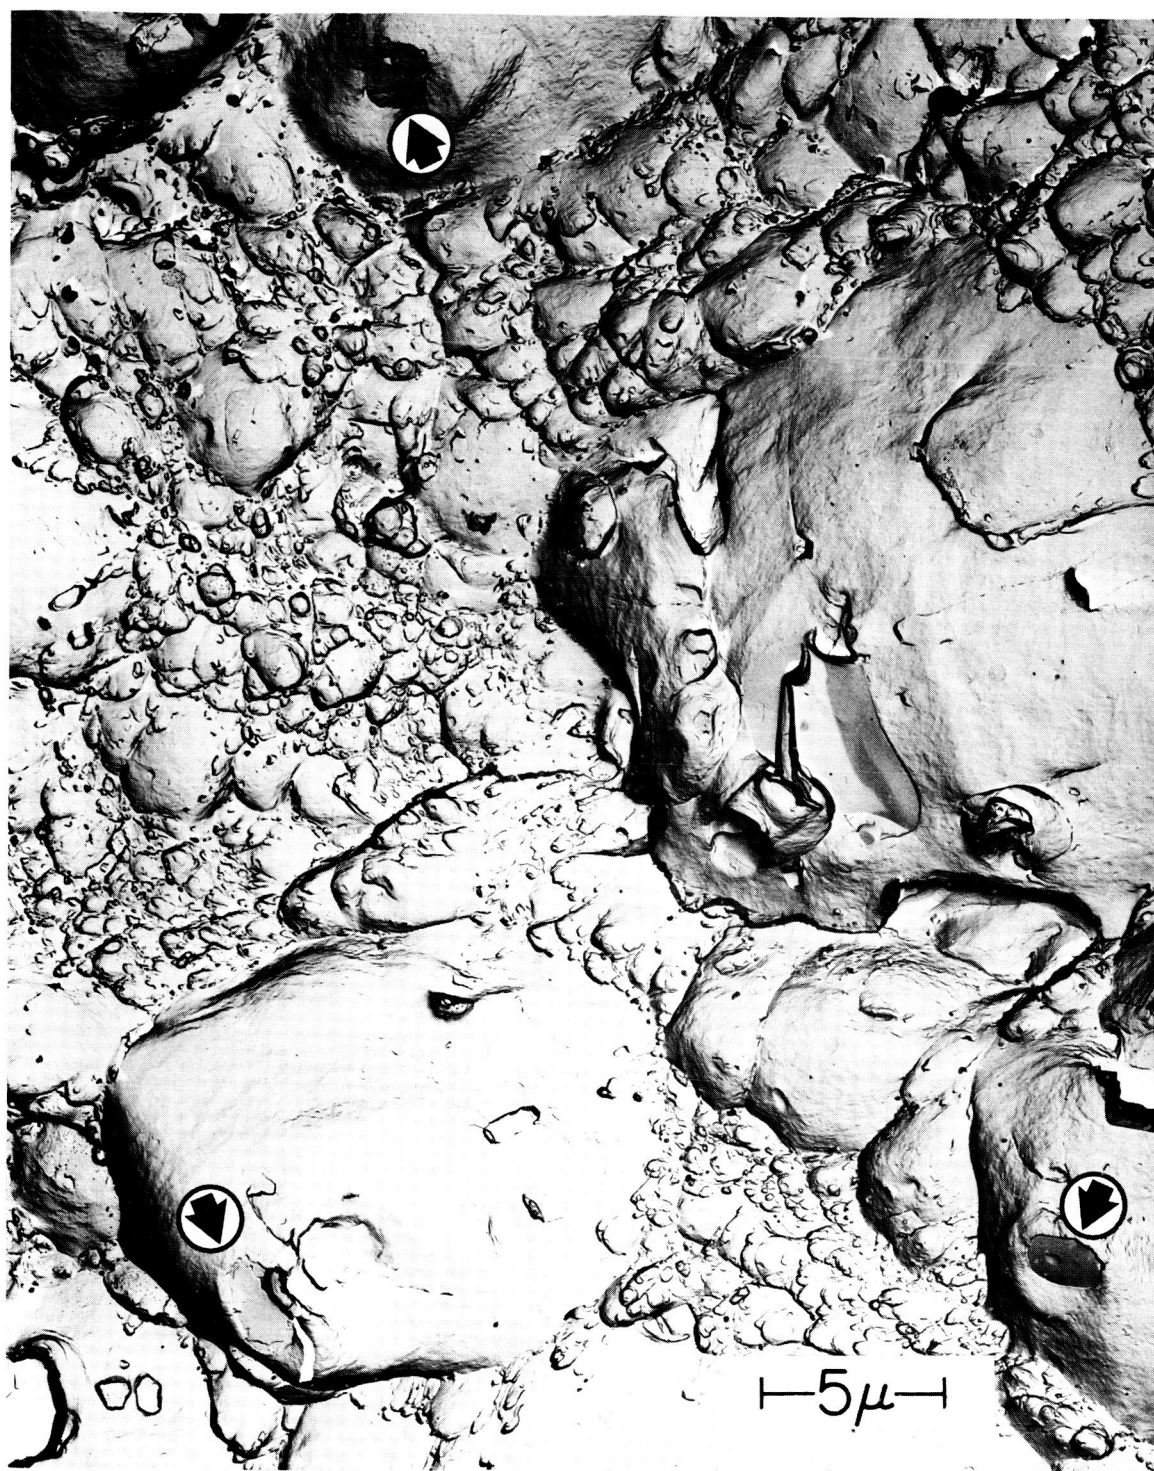
FIGURE 21. FRACTURE SURFACE OF 2219-T87 BASE METAL TENSILE SPECIMEN. Fractograph taken in central "fibrous" region. Note the range of size of dimples. Arrows indicate origin of larger dimples at second-phase platelets.

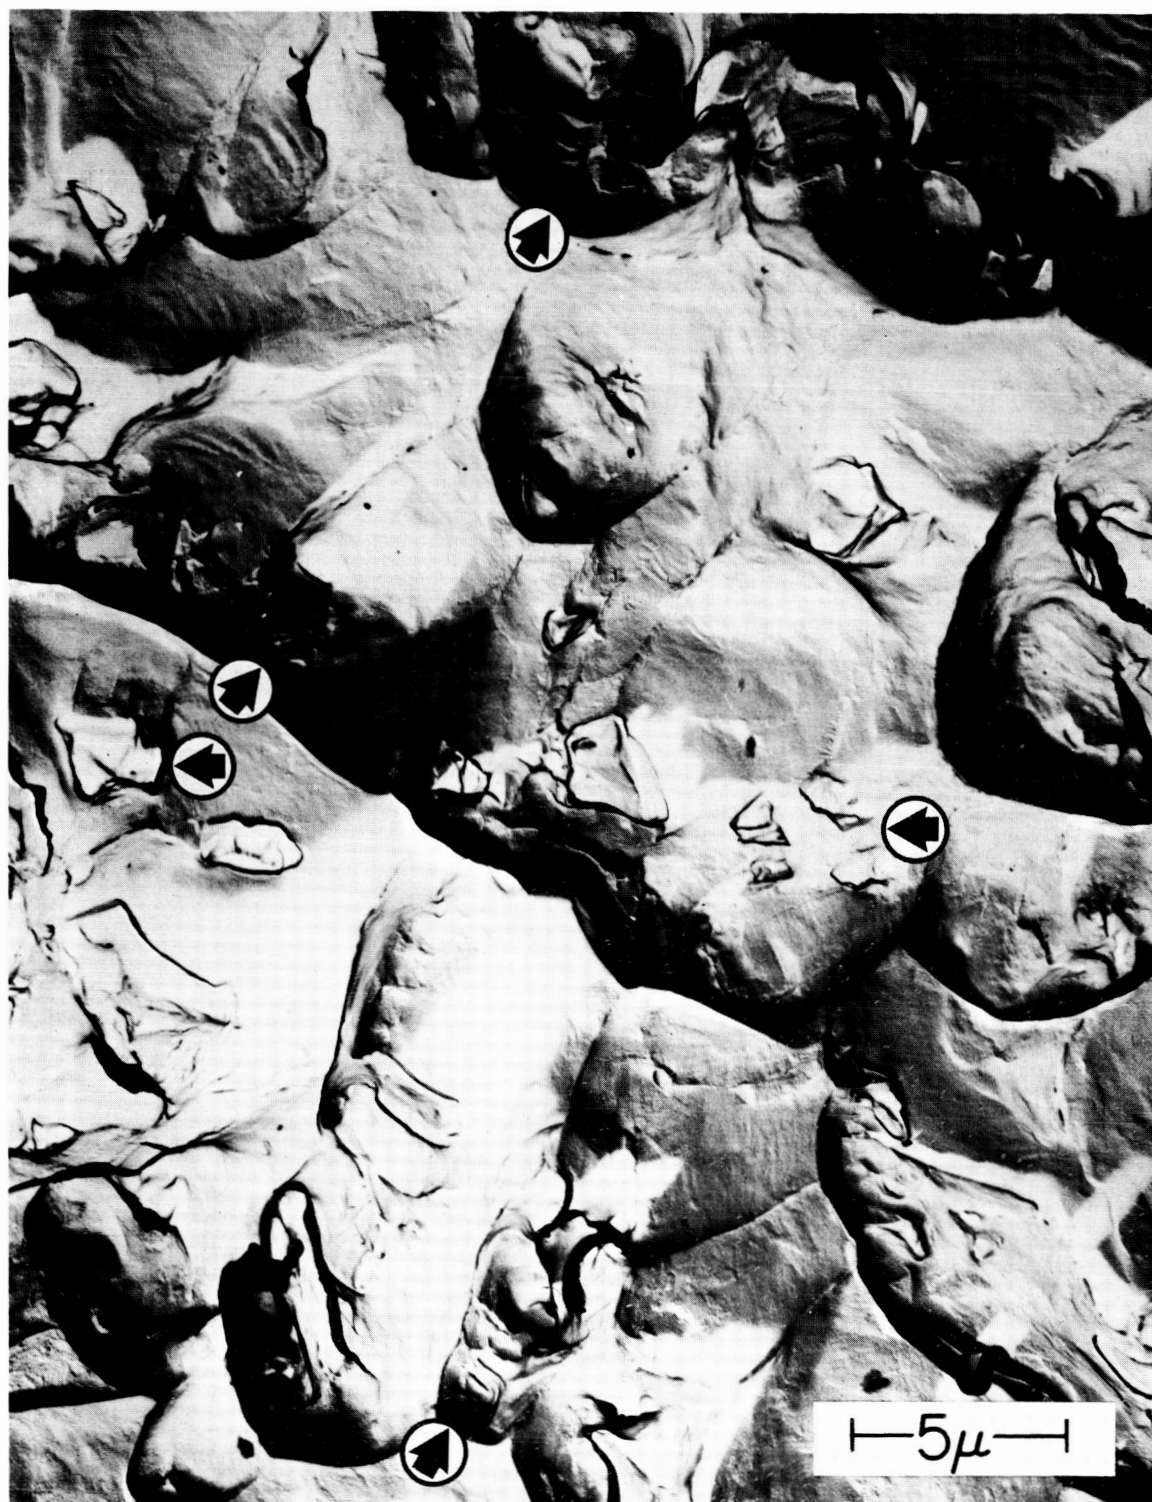
FIGURE 23. FRACTURE SURFACE OF 2219-T87 WELDED JOINT TENSILE SPECIMEN. Specimen tested with weld crowns machined off. Fractograph taken from location near root of weld passes (Area 1, Figure 18). Note irregular shape of shear dimples (oblique arrows) and dispersed second-phase particles in fracture surface (horizontal arrows).

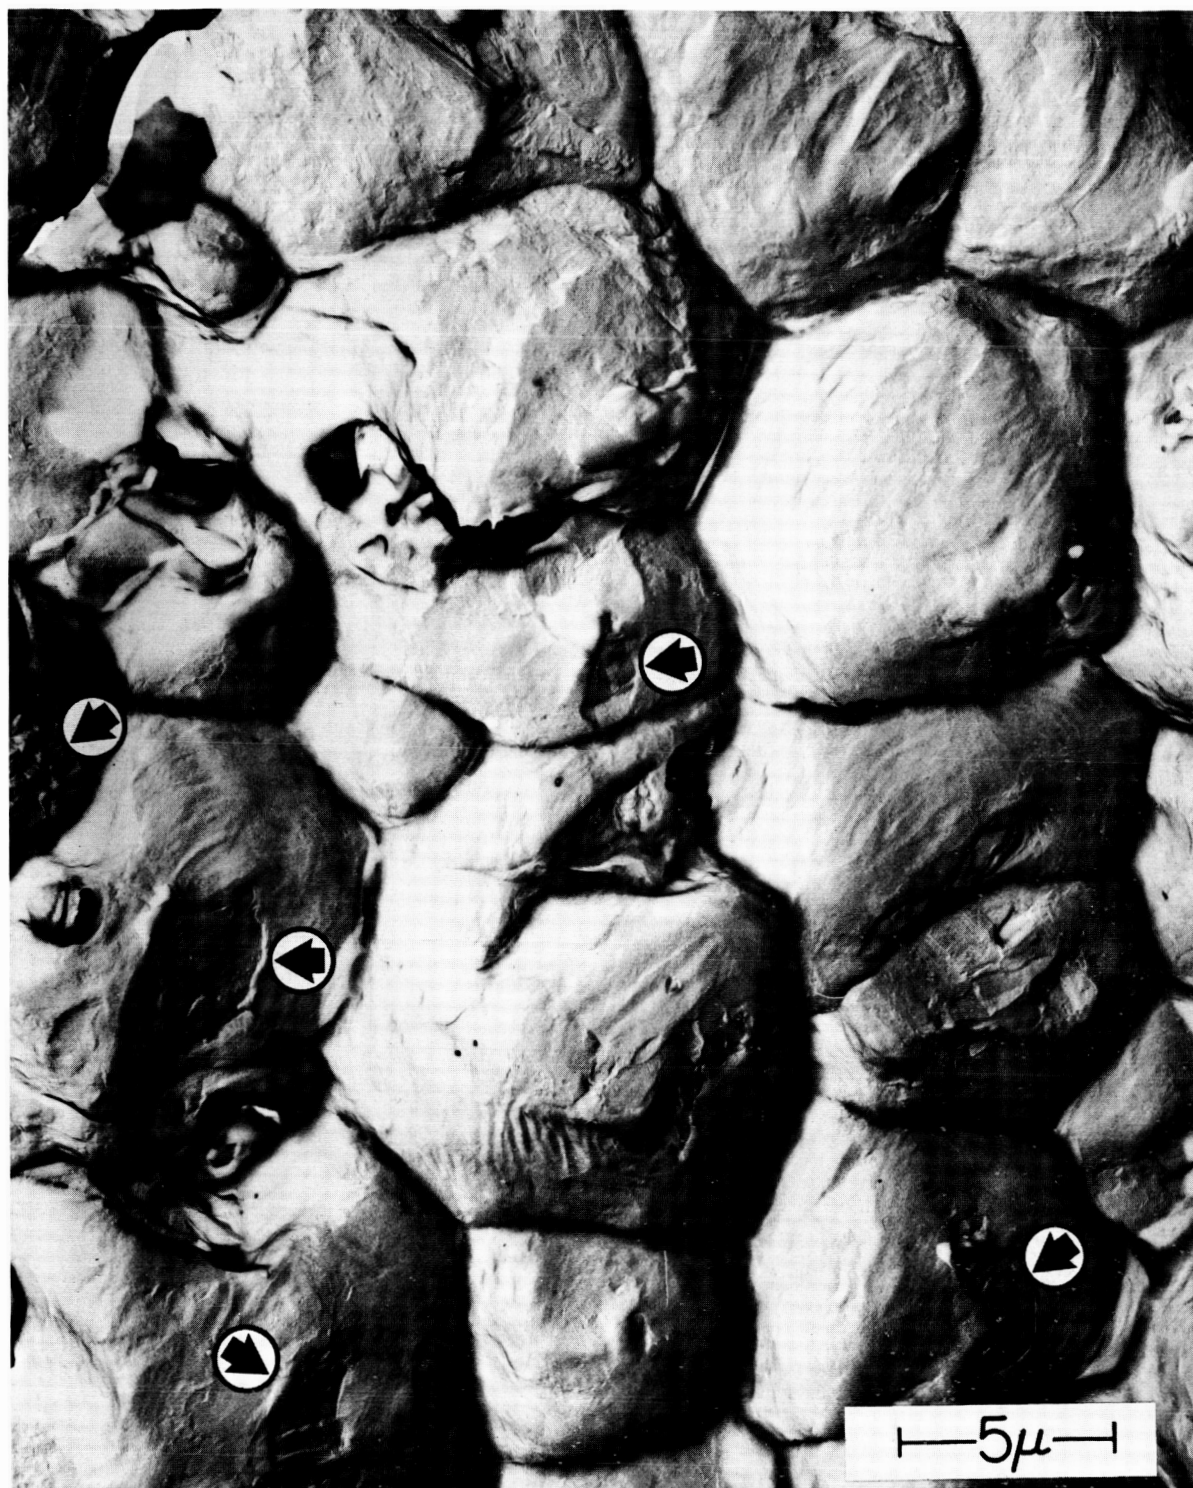
FIGURE 24. FRACTURE SURFACE OF 2219-T87 WELDED JOINT TENSILE SPECIMEN. Specimen tested with weld crowns machined off. Fractograph taken from location near root of weld passes (Area 2, Figure 18). Note the large, uniform, equiaxed dimples. Arrows indicate origin of dimples at second-phase platelets.

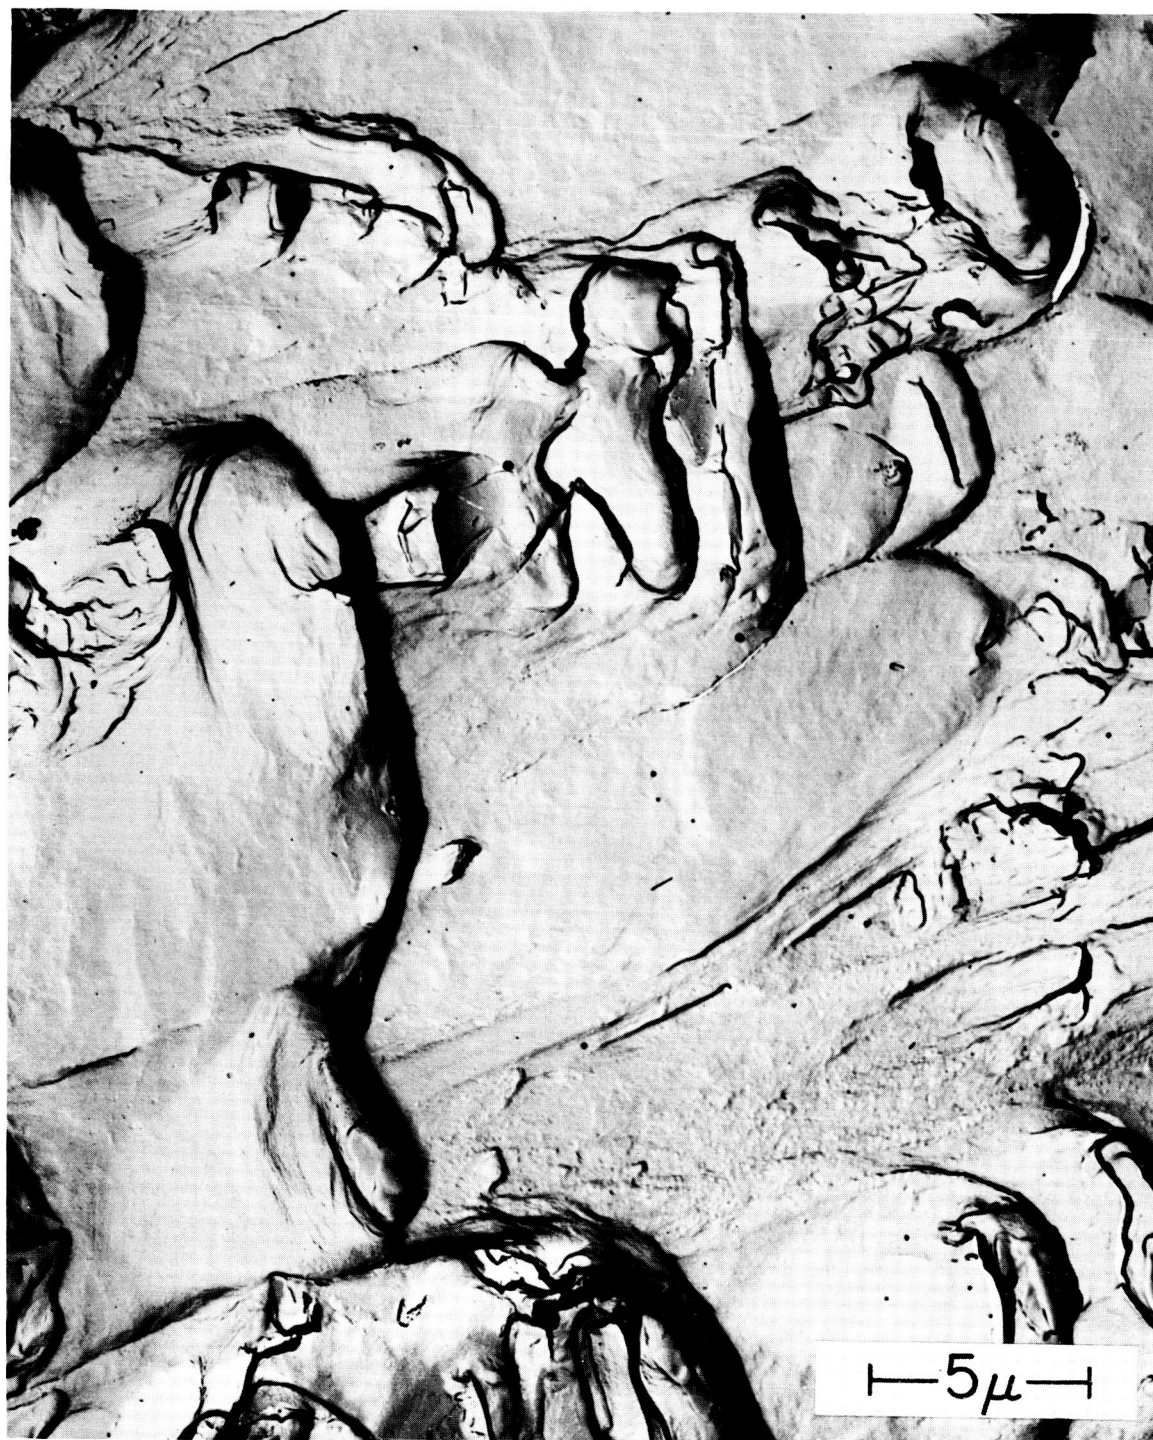
FIGURE 25. FRACTURE SURFACE OF 2219-T87 WELDED JOINT TENSILE SPECIMEN. Specimen tested with weld crowns intact. Fractograph taken from location within second weld pass (Area 1, Figure 19). Note irregular shape of shear dimples.

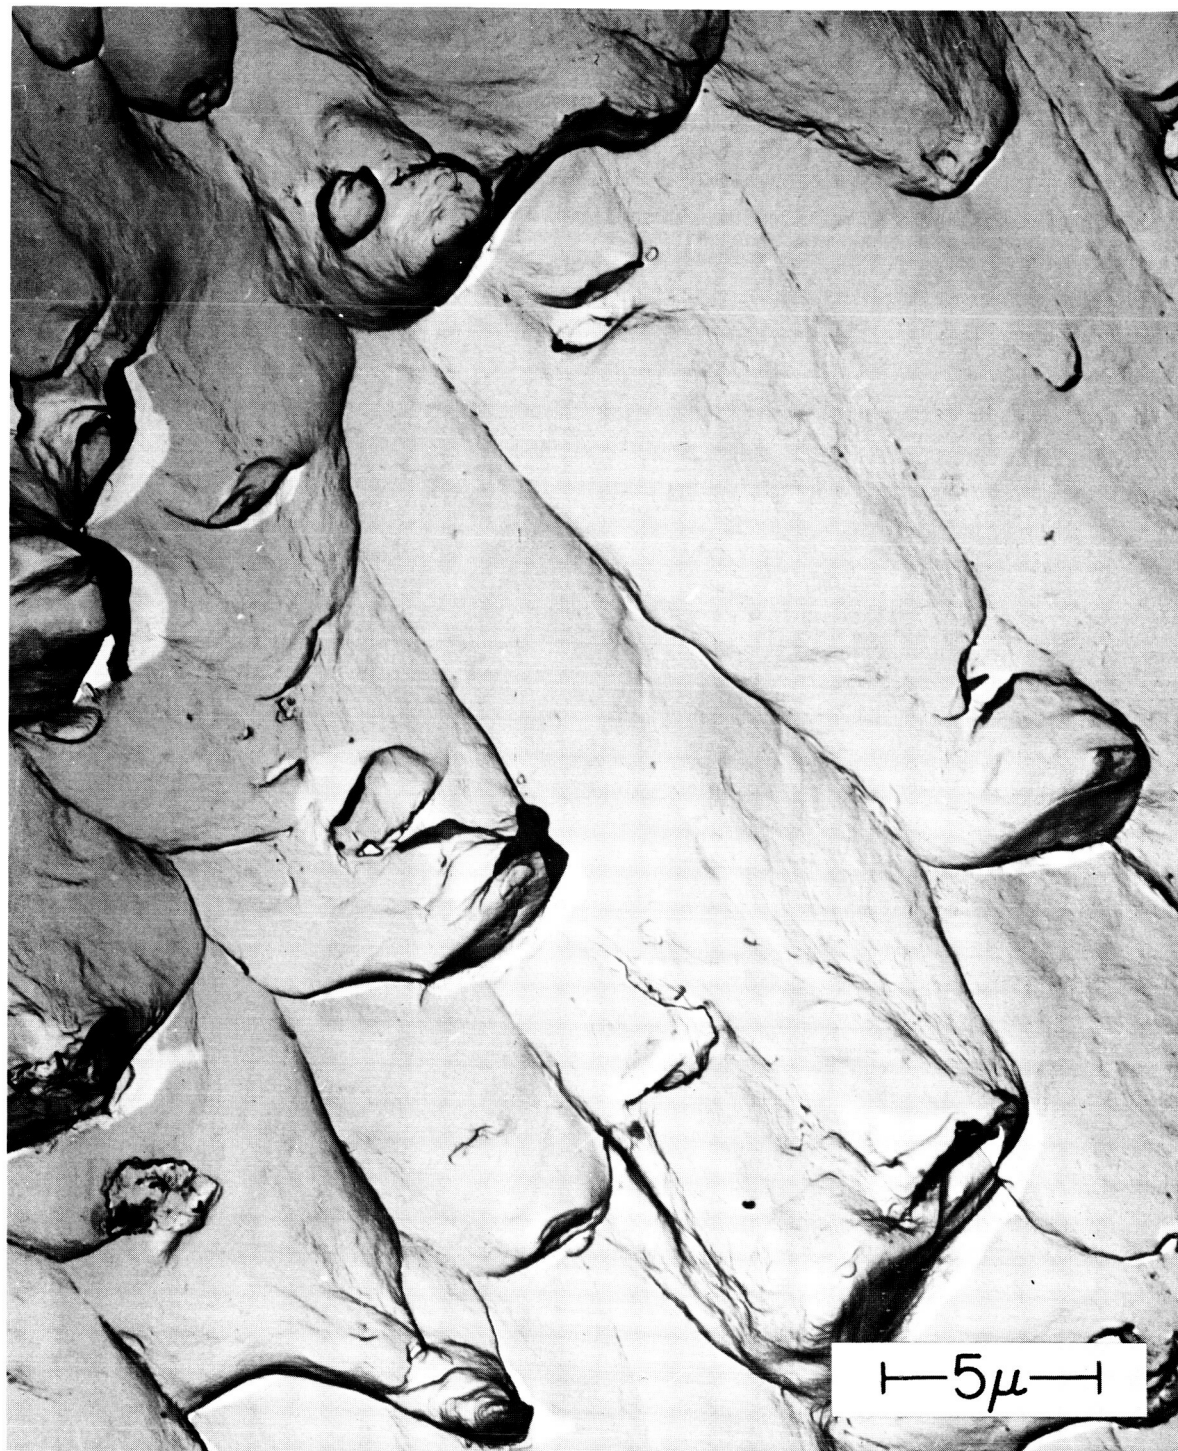
FIGURE 26. FRACTURE SURFACE OF 2219-T87 WELDED JOINT TENSILE SPECIMEN. Specimen tested with weld crowns intact. Fractograph taken from location within first weld pass (Area 2, Figure 19). Note the extent of elongation of the shear dimples.

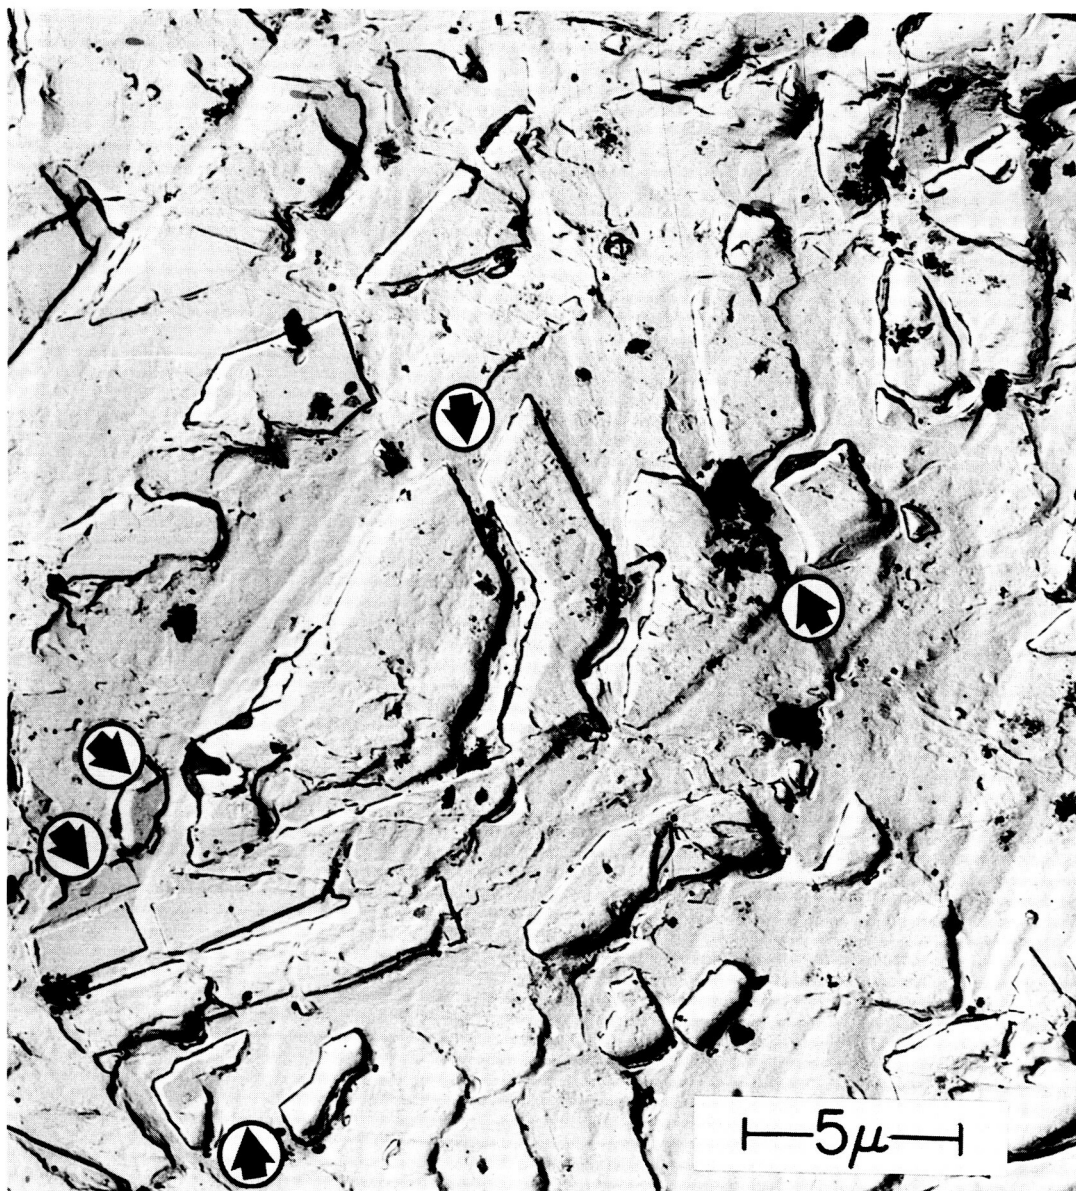
FIGURE 27. FRACTURE SURFACE OF 2219-T87 WELDED JOINT TENSILE SPECIMEN. Specimen tested with weld crowns intact. Fractograph taken from location near toe of second weld pass (Area 3, Figure 19). The region shows remnants of fractured second-phase platelet over extended area. Arrows indicate mating pieces of platelet.

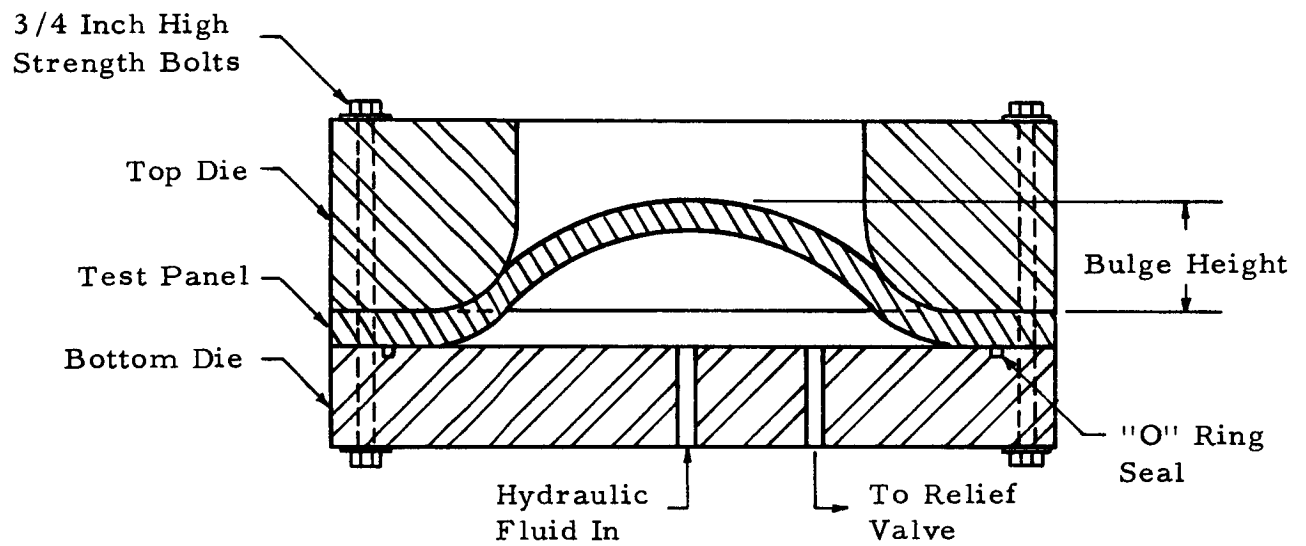
FIGURE 29. CROSS SECTION OF THE HYDRAULIC BULGE TEST FIXTURE
